REMANUFACTURED PROCESS FOR PIPELINE AND CENTRIFUGAL PUMPS

Remanufactured Process for Pipeline and Centrifugal Pumps

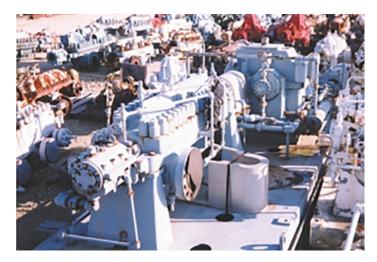
Examples of some of the more than 1000 used multistage pumps in PumpWorks' inventory.
